Technical Bulletin No. TB-070408E - PART I

Subj.: VISATRON Oil Mist Detector Type VN 115/ 87, VN116/87, VN215/87
and VN115/93, VN116/93, VN215/93

Reason for Oil Mist Detector False Alarms

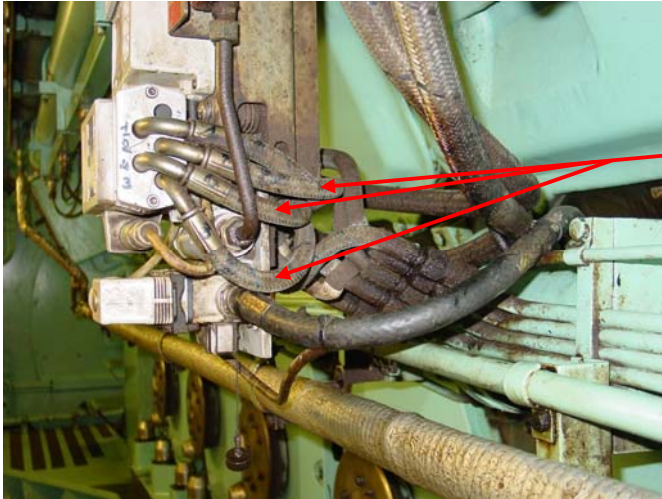
Faulty installation VN215/93:

1. Repeated false alarms, unwanted engine stops.
2. Sagging suction hoses
3. Hoses filled with water and oil
4. OMD requires constant attention and repeated cleaning of suction hoses with compressed air

Solution:

Install hoses with proper (shorter) length with continuous rising slope to valve box.

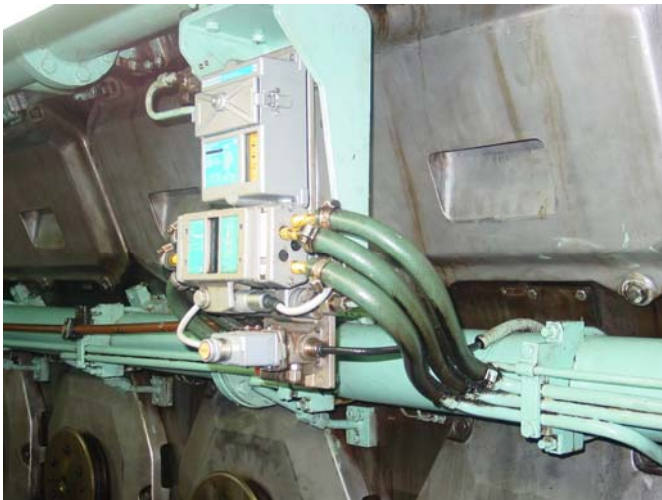
Functional installation VN215/87:

1. No false alarms, unless excessive water content is found in the lube oil
2. Suction hoses have proper slope
3. Hoses do not fill with water or oil
4. OMD requires minimal attention

Recommendation:

Install Measuring Head Heating Element, Part No 10671 to eradicate potential false alarms.

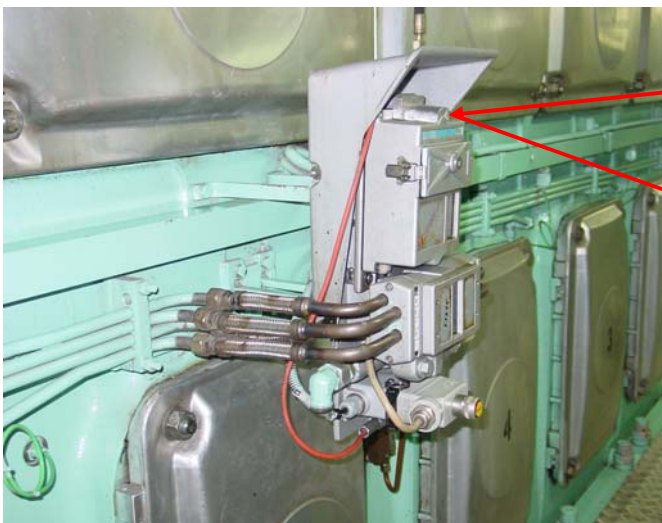
Functional installation VN215/87:

1. No false alarms, Measuring Head Heating Element 10671 is installed
2. Suction hoses are not sagging
3. Hoses do not fill with water or oil
4. OMD requires minimal attention

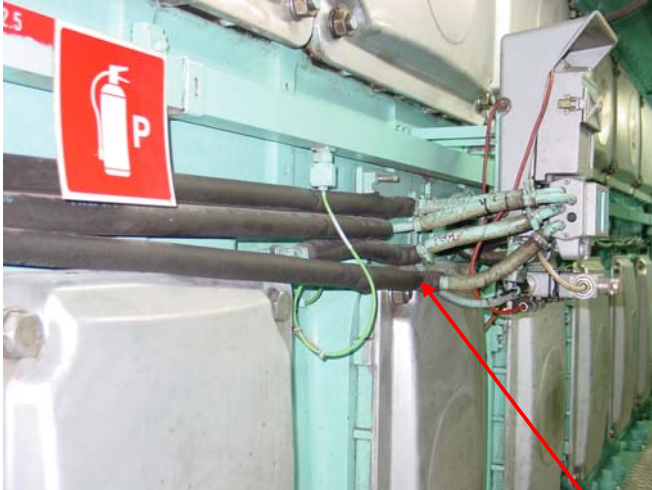
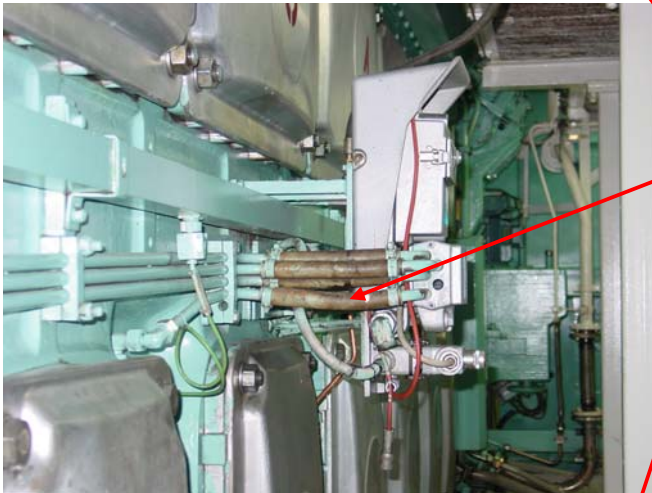
Faulty installation of VN215/87:

1. Sagging pipe & suction hoses
2. Hoses fill with water and oil
3. OMD requires repeated cleaning of suction hoses with compressed air

Solution:

Install pipes and hoses with continuous ascending slope to valve box.

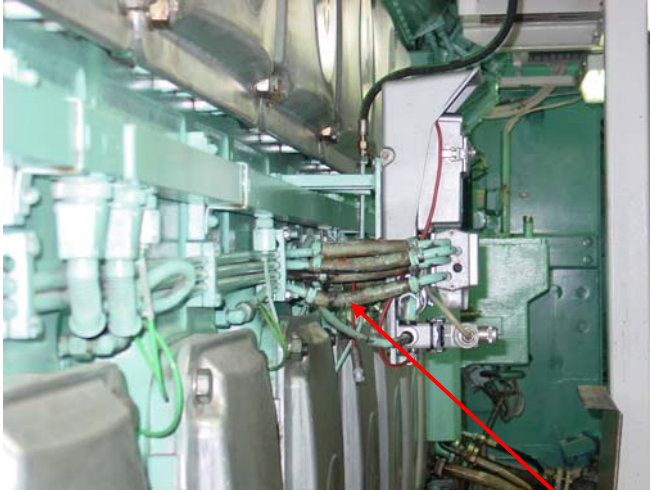
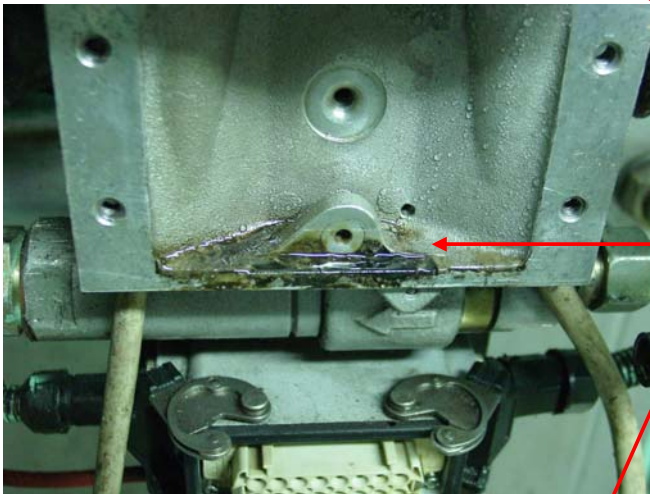
Sagging suction pipes and hoses can produce false alarms and unwanted engine stops.

Accumulating water and oil in OMD cavities and valve box requires repeated OMD cleaning with compressed air.

Solution:
Install pipes and hoses to valve box with continuous ascending slope.

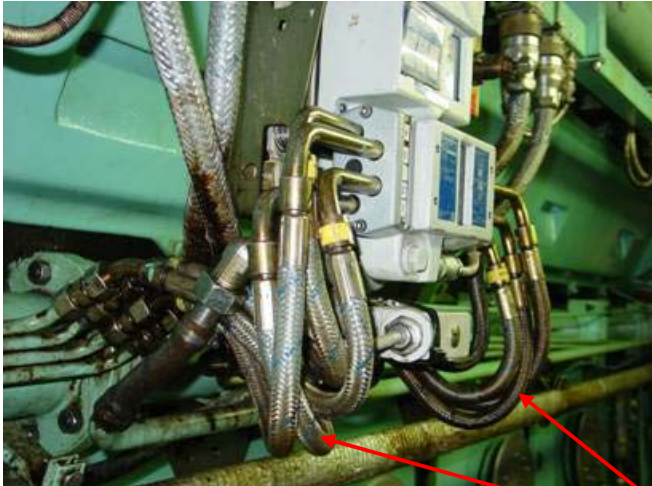
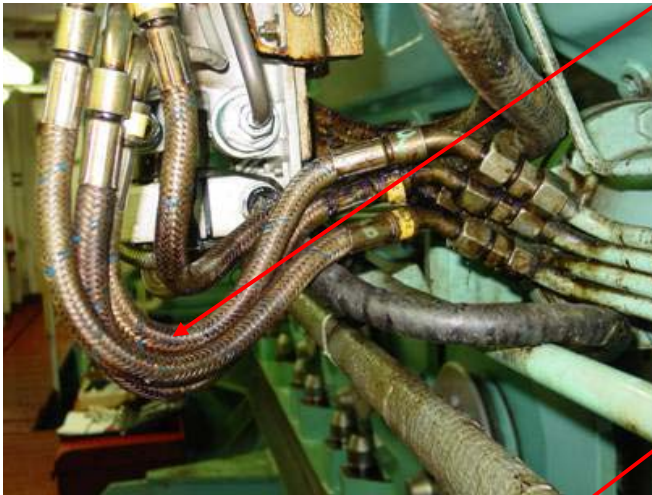
Sagging suction hoses of this installation will cause constant operation disorder.

Accumulating water and oil in flexible hoses produces false alarms and requires repeated cleaning of suction pipe system and OMD with compressed air.

Solution:
Install OMD, pipes and hoses to valve box with continuous ascending slope.
