Technical Bulletin No. TB-070408E - PART II

Subj.: VISATRON Oil Mist Detector Type VN 115/87, VN116/87, VN215/87

Reasons for Oil Mist Detector's Delayed Reaction and False Alarms

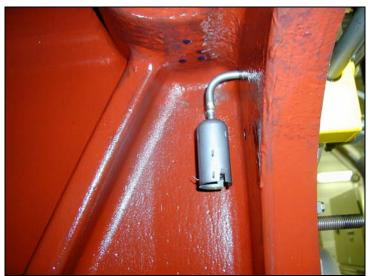
<u>Fig. 6 & 7</u>: The suction funnels in these crankcase compartments will ensure an effective oil separation and permit the unobstructed oil mist transfer to the suction pipes of the OMD system. The suction funnel with the long cup design shown on the right (double labyrinth inside) has significantly improved the oil mist sampling and can be utilized in engines with CW or CCW crankshaft rotation.
