**CRANKCASE EXPLOSION
CASUALTY INVESTIGATION**

BRITISH VALOUR - OFFSHORE BERMUDA

23.03hrs (GMT) 18 MARCH 2001

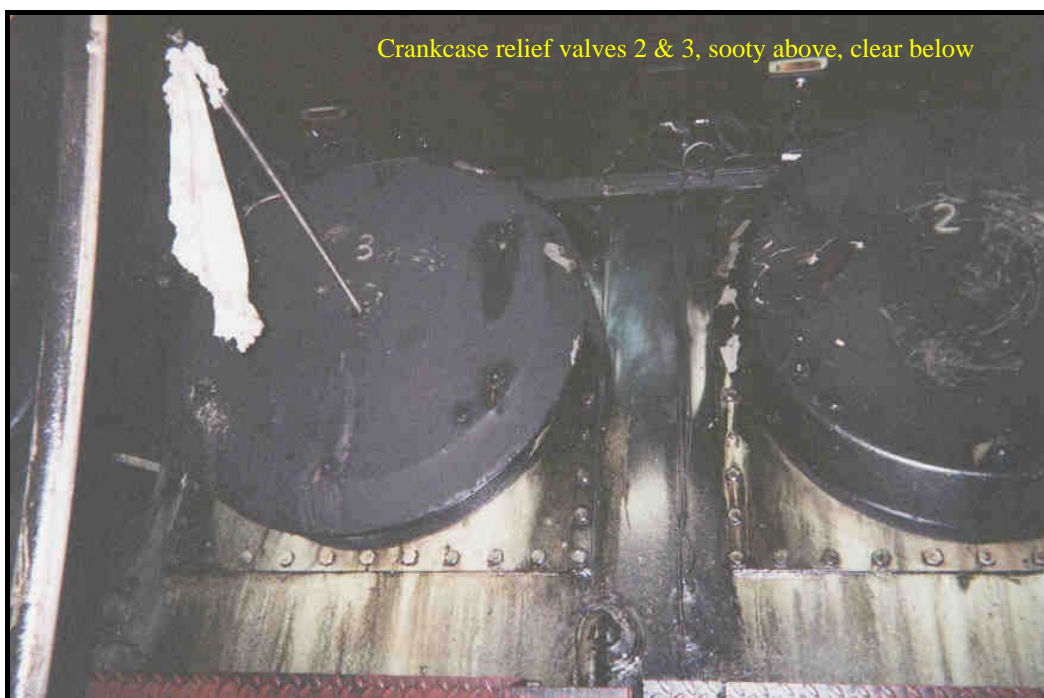
- 2.4 Ships staff performed a crankcase inspection, bearings and running surfaces were checked but nothing immediately obvious was discovered, a very small amount of 'squeezed' bearing white metal was found on top of the oil sump near no.8 main bearing, but not enough to raise suspicion of a hot spot. Engine monitoring systems indicated no bearing high temperature alarms initiated before or after the event and discoloration on internal surfaces was negligible to none existent.
- 2.5 External signs were that all eight crankcase explosion relief valves (located on the starboard side of the engine) had lifted, nos. 2, 5 and 6 were found to have incorrectly seated after closing under pressure from their return springs. Additionally two of the sealing rubber 'o' rings had become dislodged from their seats.

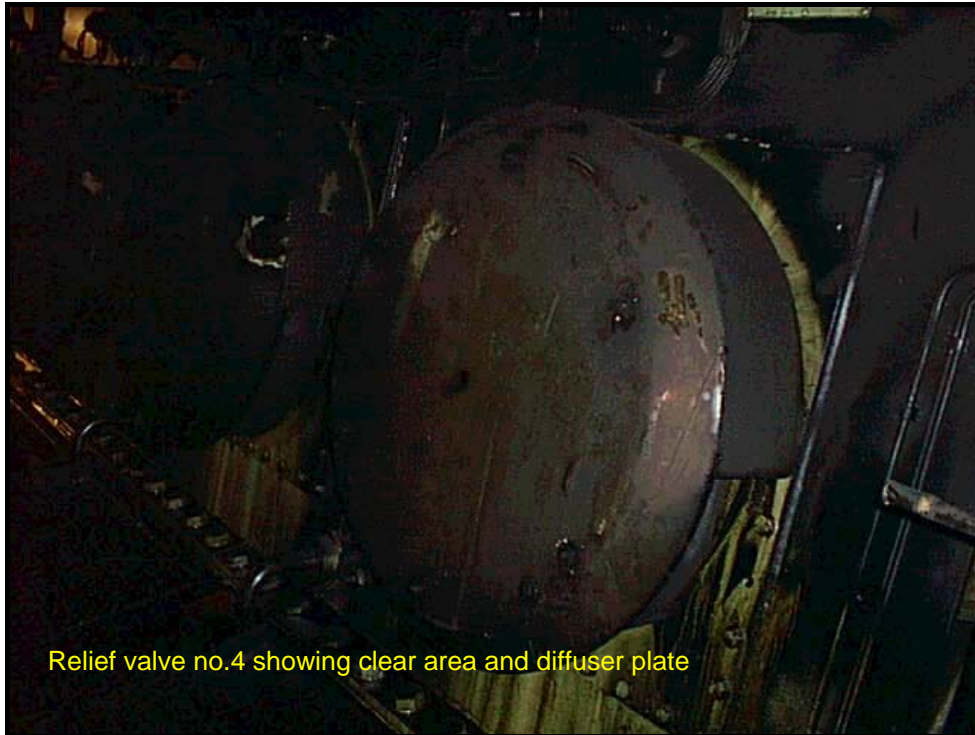
- 2.6 Paintwork immediately adjacent to the relief door periphery was relatively clean but approx. 40mm away it was covered in oily soot and approx. 100mm away, it was covered in dry soot. This soot was noted to be in the region “protected by the diffuser shield” (above the doors) whilst in the area below the diffuser shield (where gases are directed) the paintwork was observed to be less affected.

Relief valve no.4 showing clear area and diffuser plate

- 5.1 As a result of the evidence discovered during the investigation, we would propose in the interests of safety to recommend that crankcase relief valve diffusion plates be removed due to the reduction in effectiveness of flame arresting systems caused by the concentration of expelled gases. It is proposed that this would be achieved by making a submission to IMO for consideration and discussion at DE 46 (2003).

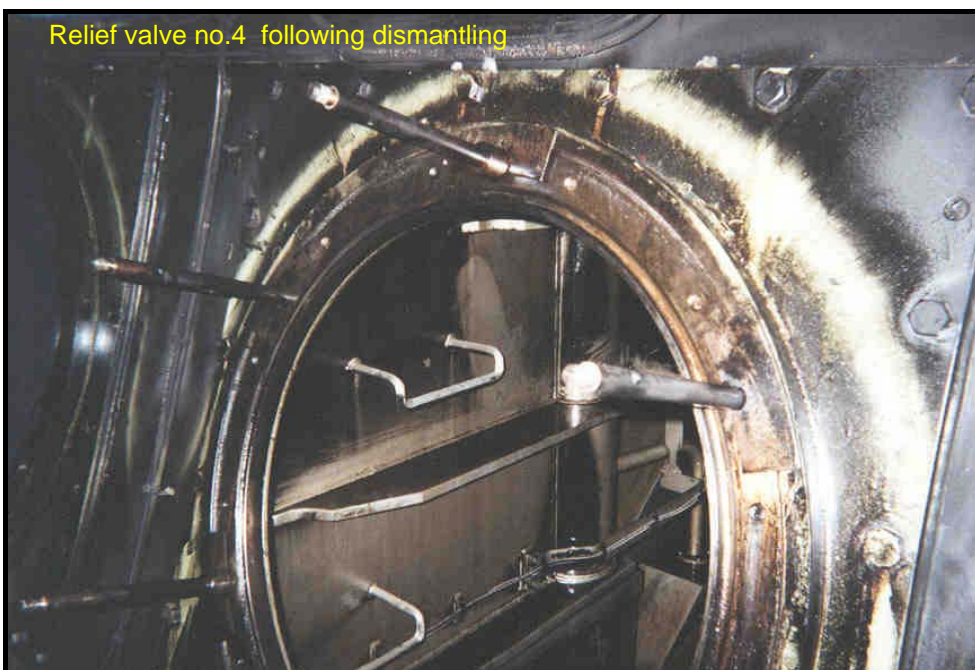
Relief valve no.4 following dismantling

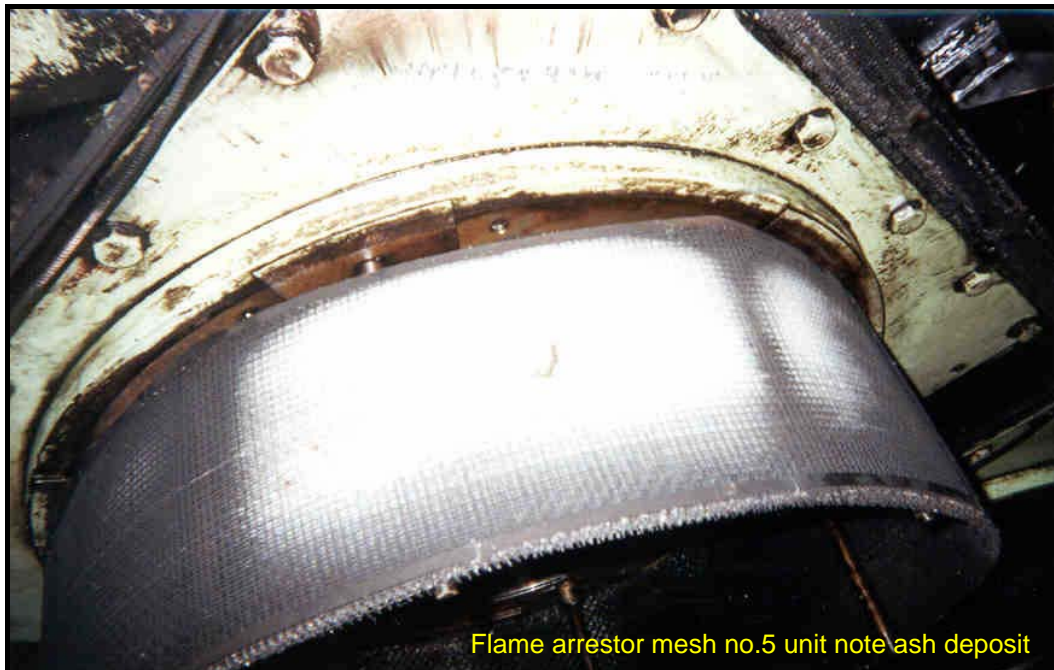
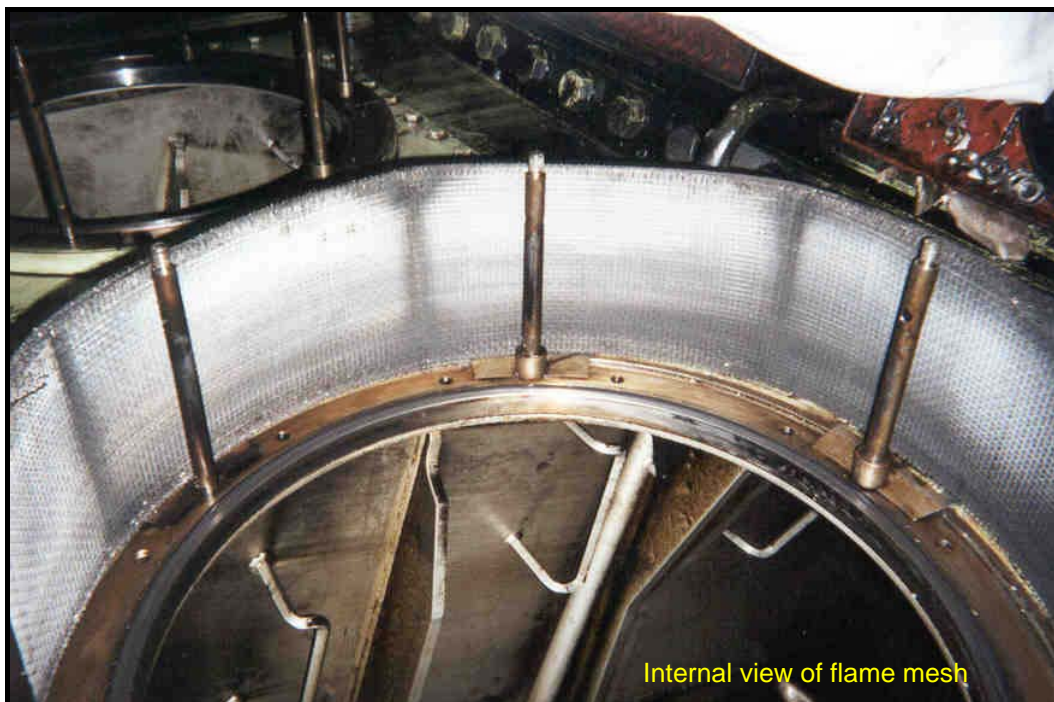
- 2.7 Flame arrestor mesh fitted to the relief valves Nos. 2,4,5,6 was seen to be very dry and had a whitish ash on the side exposed to the crankcase during lifting/operation, of these, no.5 exhibited the most obvious signs of high temperature

- 3.4 The flame arrestors failed to prevent expelled oily mist ignition and therefore did not perform as designed.
- 3.5 The crankcase oil mist monitor was found inoperable, the attending service engineer advised this to be a result of overpressure caused by the explosion(s), a crankcase high mist alarm occurred in the five second period between the first abnormality indication - ME governor minor fault and the ME cyl no.1 outlet high temp and would tend to support the theory that the damage occurred as a result of the explosion. Due to the short time-span between first indication and explosion, it would be doubtful if the monitor could have slowed the engine quickly enough to prevent an explosion.

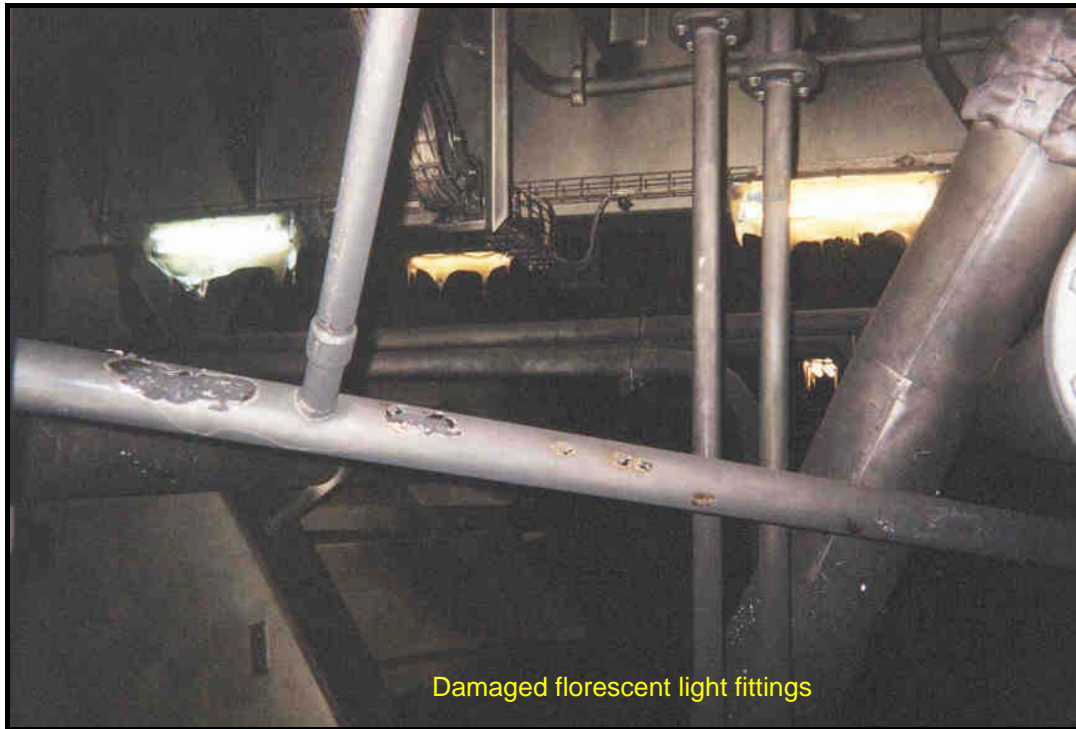
- 2.9 Significant soot and smoke damage on the starboard ships side, plates, walkways, pipes and ducts was apparent.
- 2.10 A number of fluorescent light diffusers had largely melted away, the area from the bottom plates level right up to cylinder head level on the starboard side of the engine room was affected

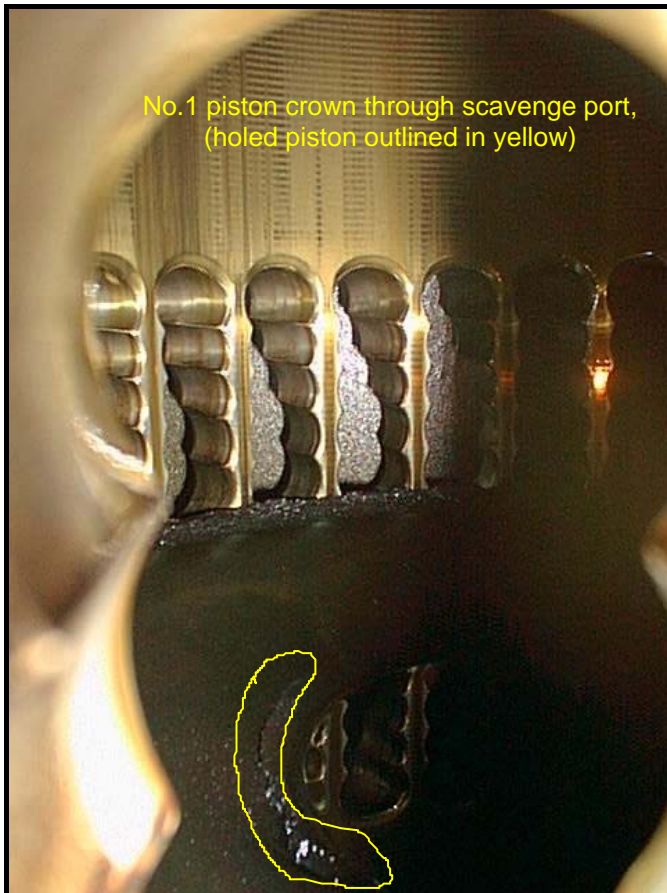
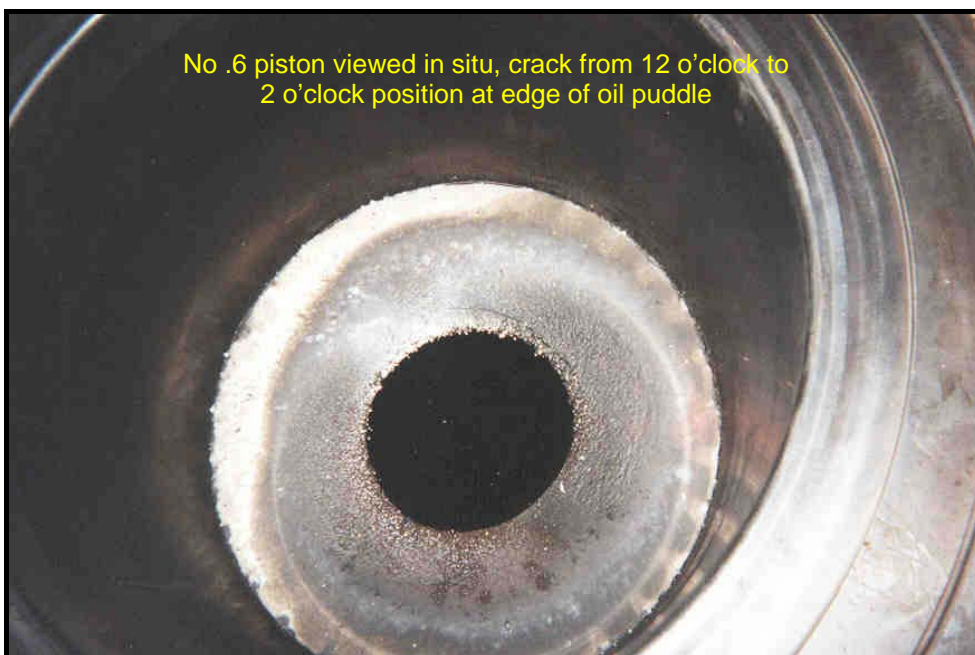
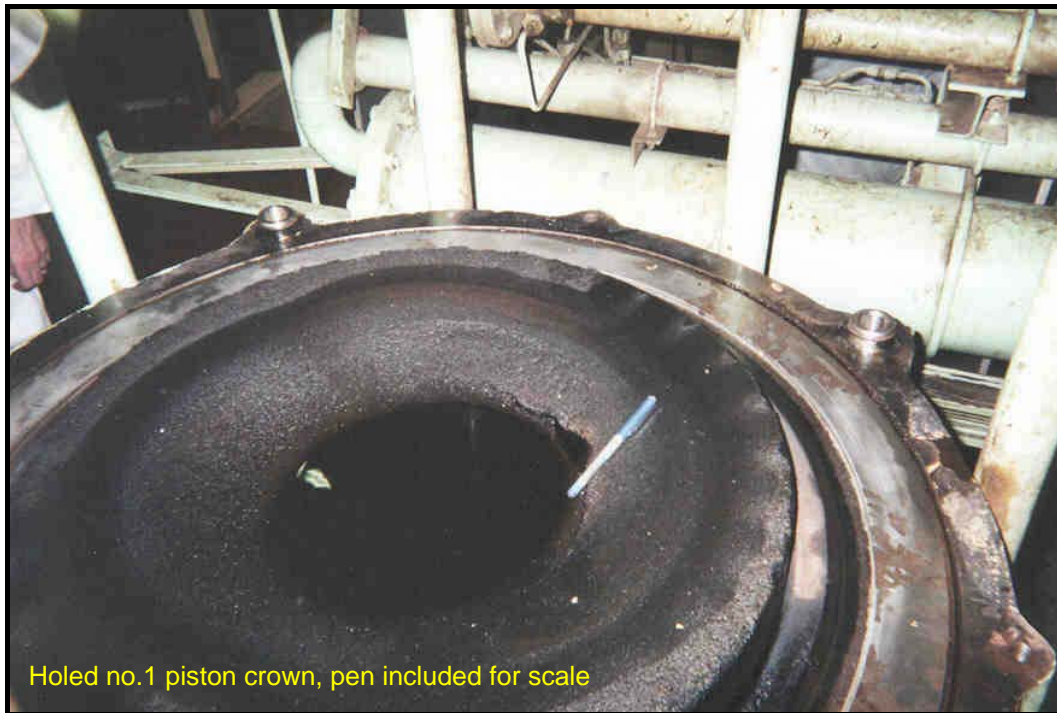
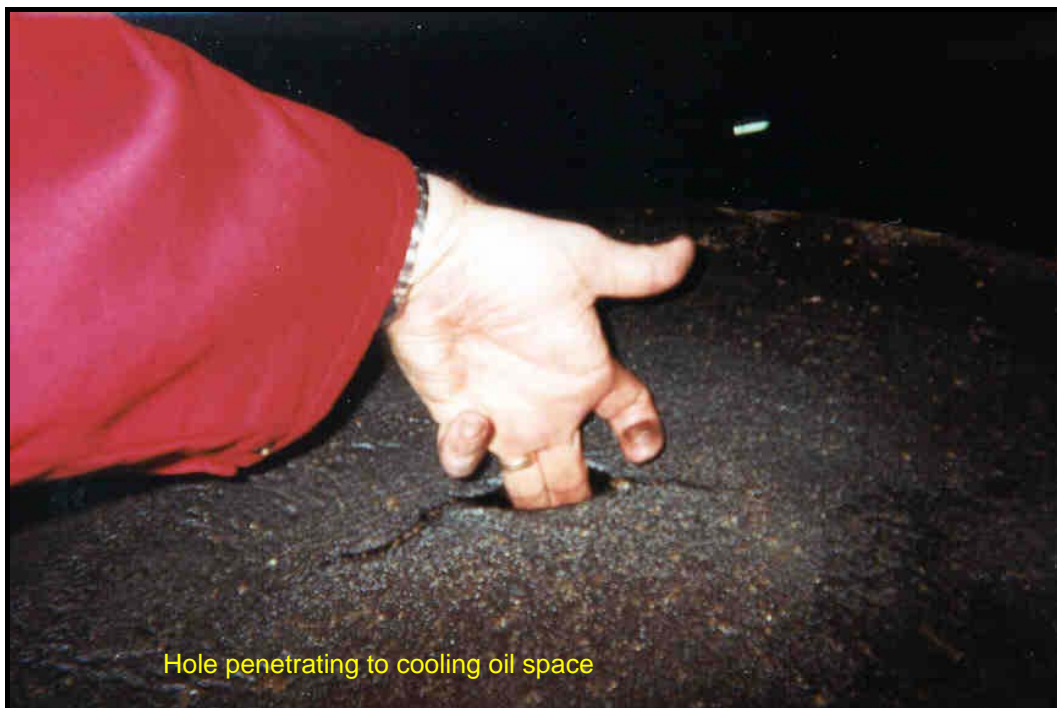
- 2.16 No.1 Piston crown was found to be cracked and holed which penetrated to the oil cooling space thereby allowing direct communication of the combustion space with the crankcase via the cooling oil passages and would indicate a probable initiation site.

- 4.1 The failure of no.1 unit, piston crown, allowed direct communication of the combustion chamber with the crankcase via the piston cooling oil passages. This allowed hot combustion gases to create and ignite a flammable oily mist mixture from the oil droplets normally present in the crankcase, causing a primary crankcase explosion.

- 4.3 Unusually large piston crown wear had occurred since overhaul in dry-dock in October 2000, the evidence gained indicates fuel impingement from poor atomisation which caused localised overheating and cooling oil breakdown on the internal surfaces of the crown and in turn increased the high temperature erosion in the areas of failure, ultimately leading to the mechanical failure of no.1 and no.6 piston crowns.

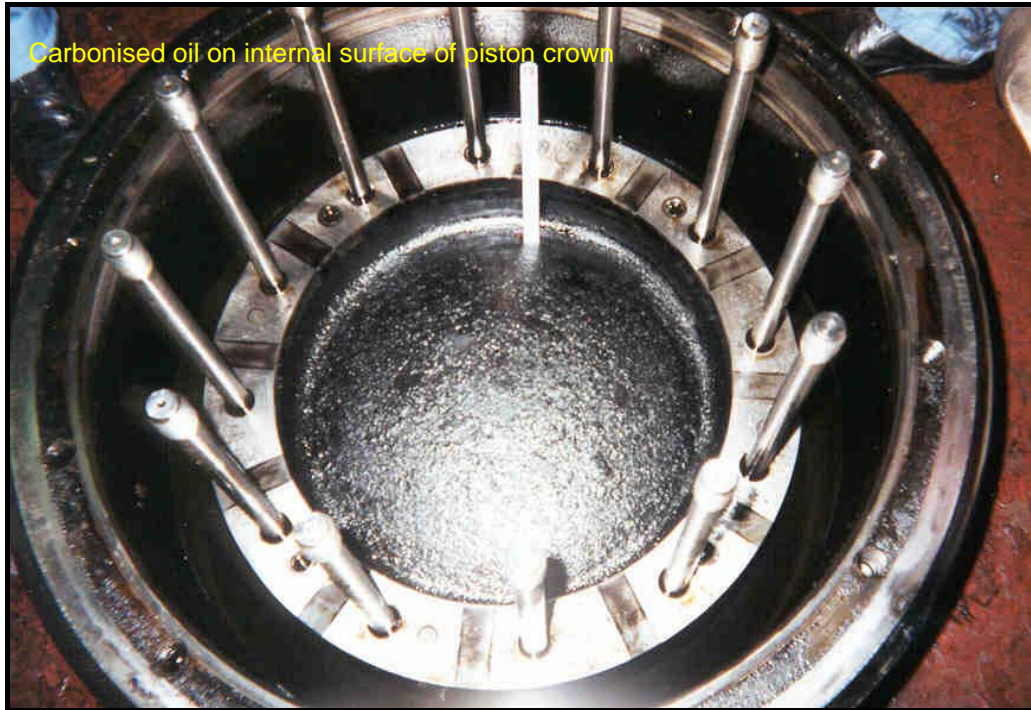
- 2.18 The scavenge space was found to be in a normal operating condition and showed no signs of internal fires.
- 2.19 Following dismantling, carbonised oil sludge was found to be coating the interior of the piston crowns.

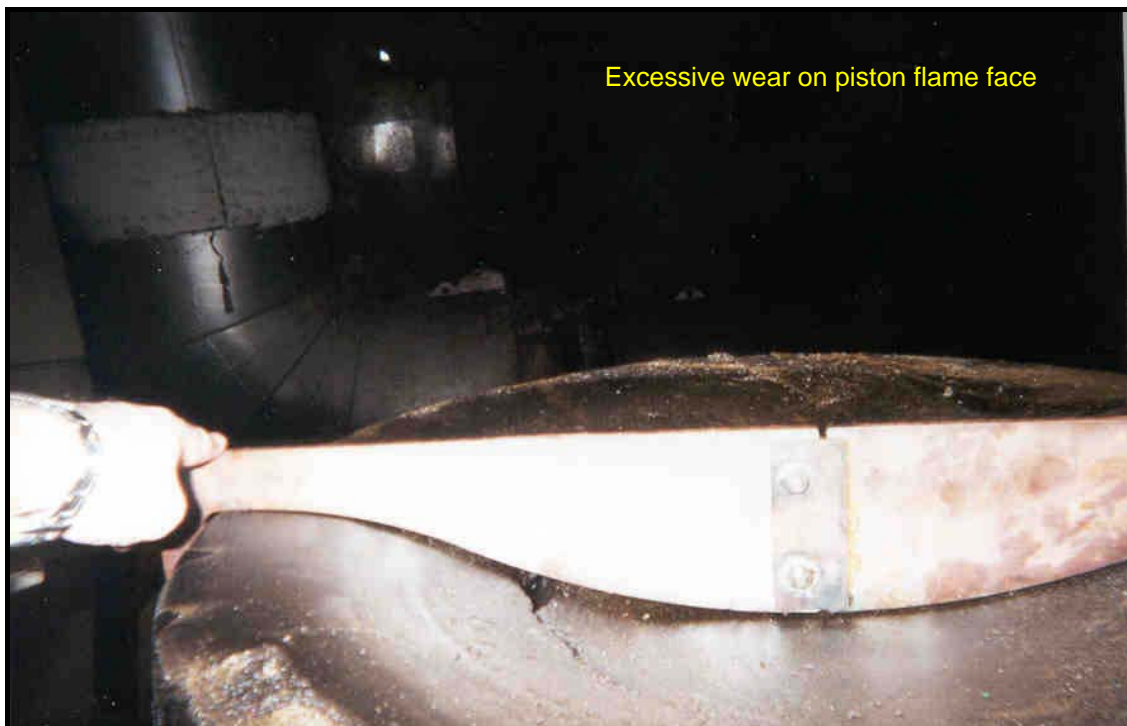
- 2.23 From historical records, it was determined that the engine performance monitoring system was not fully functional prior to the incident, this may have provided useful diagnostic information to developing problems with the combustion process.
- 2.24 During the investigation, calibrations showed No.1 and No.6 piston crowns to be out of tolerance for further use, whereas in dry dock less than eight months previously, calibrations had shown they were within wear tolerance for a further service period of 8,000 -10,000 running hours (approximately 11 - 14 months continuous service).

No.1 exhaust valve was also measured with the maximum allowed wear (12mm) and was recommended for exchange and reconditioning.
