Technical Bulletin No. TB-070408E - PART I

Subj.: VISATRON Oil Mist Detector Type VN 115/ 87, VN116/87, VN215/87
and VN115/93, VN116/93, VN215/93

Reason for Oil Mist Detector False Alarms

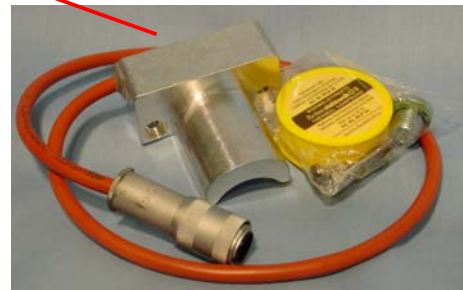
Functional installation VN215/87:

1. No false alarms, Measuring Head Heating Element 10671 is installed
2. Suction hoses are not sagging
3. Hoses do not fill with water or oil
4. OMD requires minimal attention

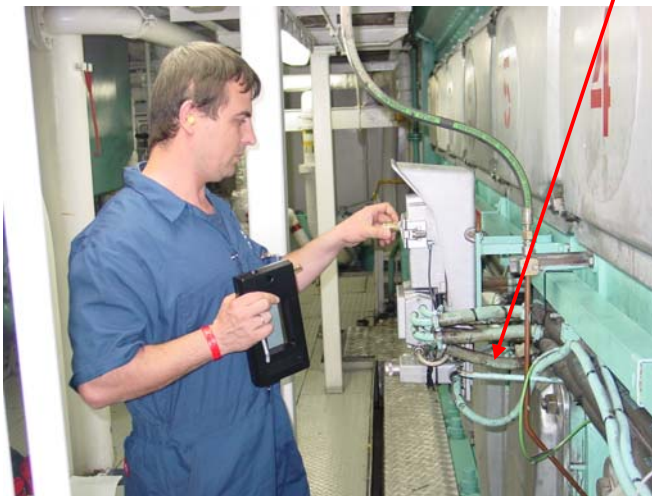
Faulty installation of VN215/87:

1. Sagging pipe & suction hoses
2. Hoses fill with water and oil
3. OMD requires repeated cleaning of suction hoses with compressed air

Solution:

Install pipes and hoses with continuous ascending slope to valve box.

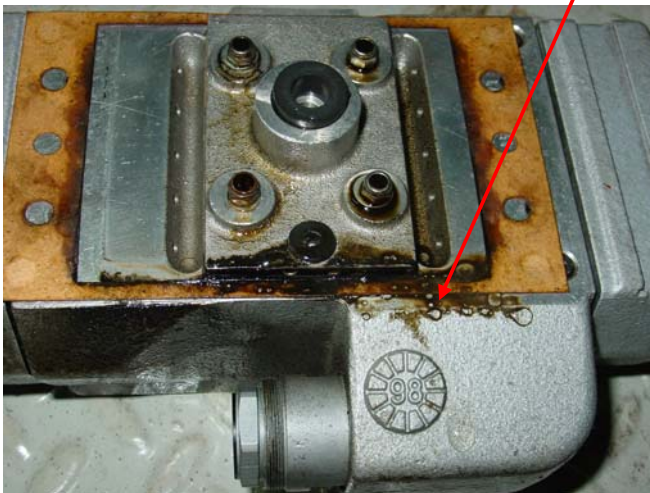
Sagging suction pipes and hoses can produce false alarms and unwanted engine stops.

Accumulating water and oil in OMD cavities and valve box requires repeated OMD cleaning with compressed air.

Solution:
Install pipes and hoses to valve box with continuous ascending slope.

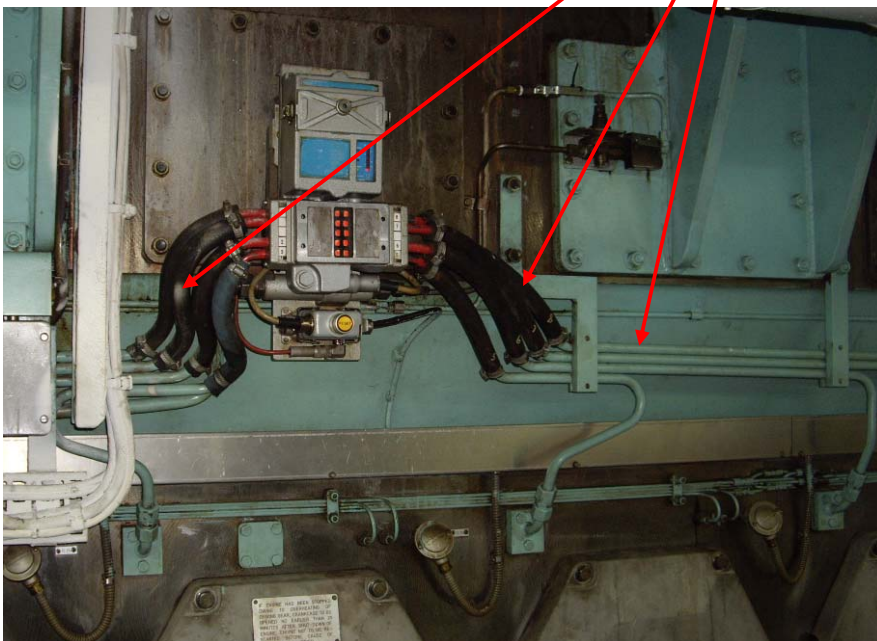
Sagging suction hoses of this installation will cause constant operation disorder.

Accumulating water and oil in flexible hoses produces false alarms and requires repeated cleaning of suction pipe system and OMD with compressed air.

Solution:
Install OMD, pipes and hoses to valve box with continuous ascending slope.
